TOWN OF SUNDERLAND CULVERT ASSESSMENT

Fall 2022

Town of Sunderland Culvert Assessment

Project Summary

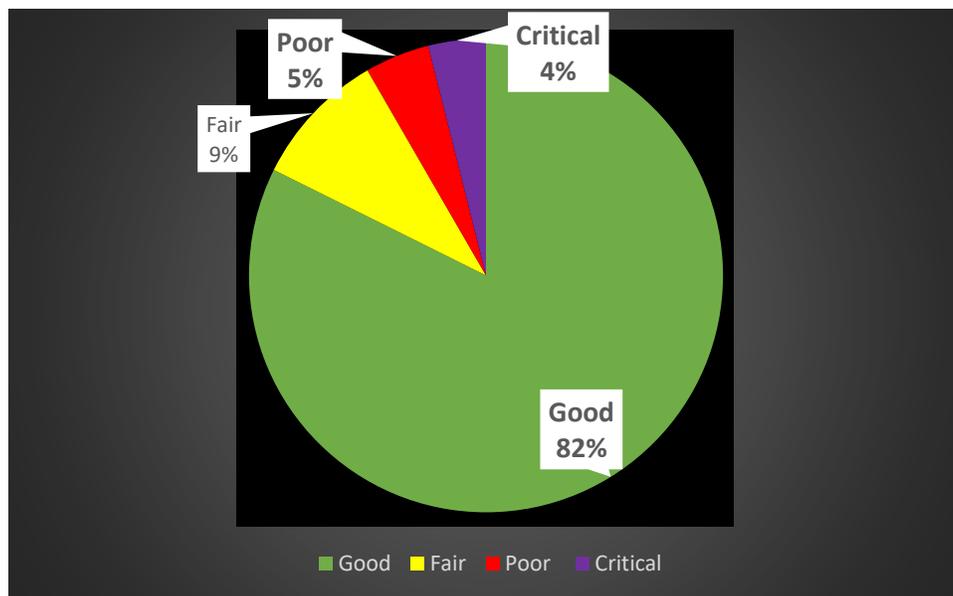
Figure 1: Condition of Sunderland's Culverts as of October 2022

Of these drainage structures, 82% were assessed as being in Good condition, while another 4% were identified as being in Critical condition needing immediate attention for either replacement or maintenance. The remaining 14% of culverts were in either Fair or Poor condition. Figure 1 below shows the condition breakdown of the condition of the Town's culverts.

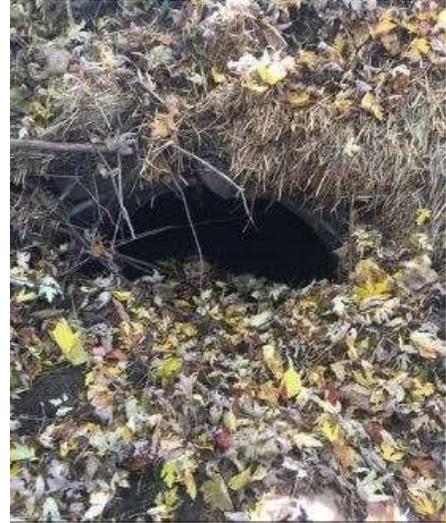
- Garage Road (Culvert 266) – (pictured right) this culvert is 75% blocked on the north side and 50% blocked on the south side. The structure is a 2 foot round plastic pipe at the inlet and is submerged more than 10 inches because of the heavy sediment. The outlet is a 2 foot metal pipe with an apron that is 50% blocked with sediment preventing proper drainage.

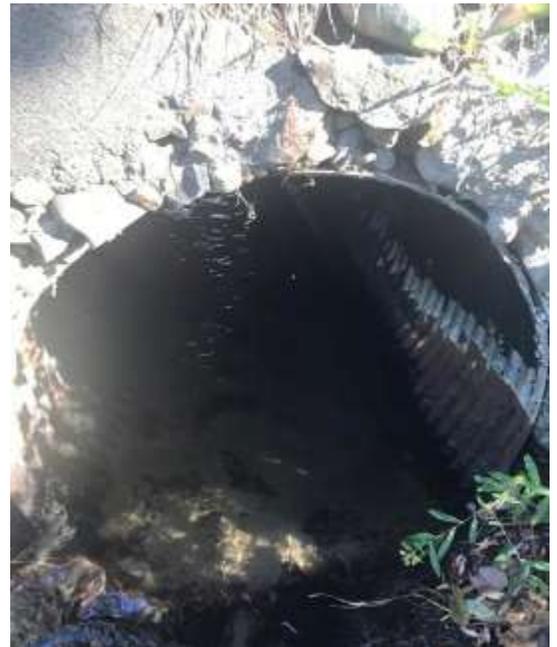
- Grobko Cross Road (Culvert 62 & 63) – #62 is a 16 inch culvert with a failing headwall on the outlet causing the road to be impacted. Culvert #63 is a 4 foot pipe with a failing headwall on the outlet which needs to be repaired. Both of these culverts are in close proximity to Mohawk Brook. (#63 pictured right)

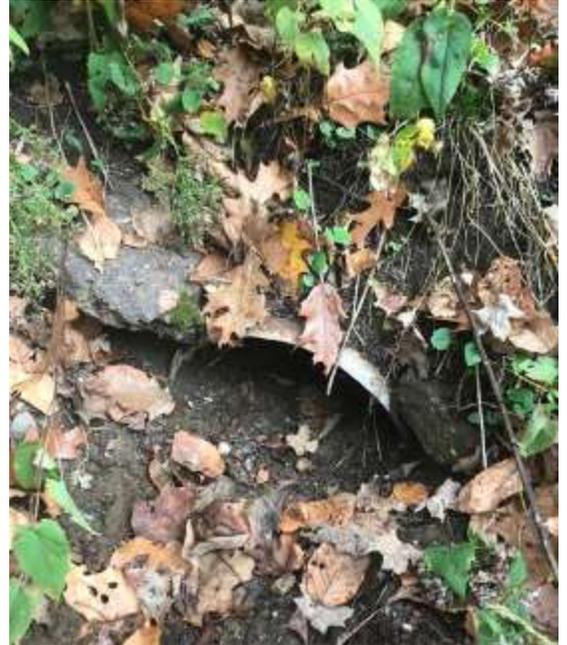
- Cross Mountain Road (Culvert 252) – this is an 18 inch metal round culvert that is approximately 50% blocked at the far western end of the road. The FRCOG identified this culvert as a major issue because it appears to be undersized for the amount of stormwater runoff the structure has to handle due to the steep slope of the surrounding land. Much of the stormwater is flowing down an entrenched roadway directly into the pipe, which has been crushed. The pipe inlet is also submerged approximately 10 inch with no headwall on the inlet or outlet. This is causing general erosion around the culvert. Because it is not sized sufficiently, the runoff causes one of the only gravel roads in the town to consistently wash out. (Pictured right)

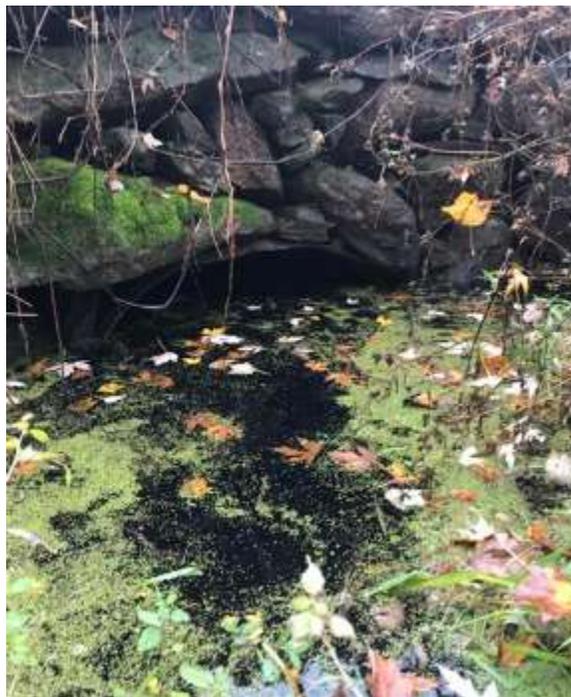
- Russell Street (Culvert 162) – this 4 foot round pipe is in poor condition due to poor drainage on the outlet side. The water from Dry Brook has backed up to the top of the pipe and could cause issues for the headwall in the future depending on freeze/thaw conditions. (pictured below)
